COMPLETION REPORT

Remedial Action Construction

**Standard Steel And Metals Salvage Yard
Superfund Site
Anchorage Alaska**

AUGUST 1999

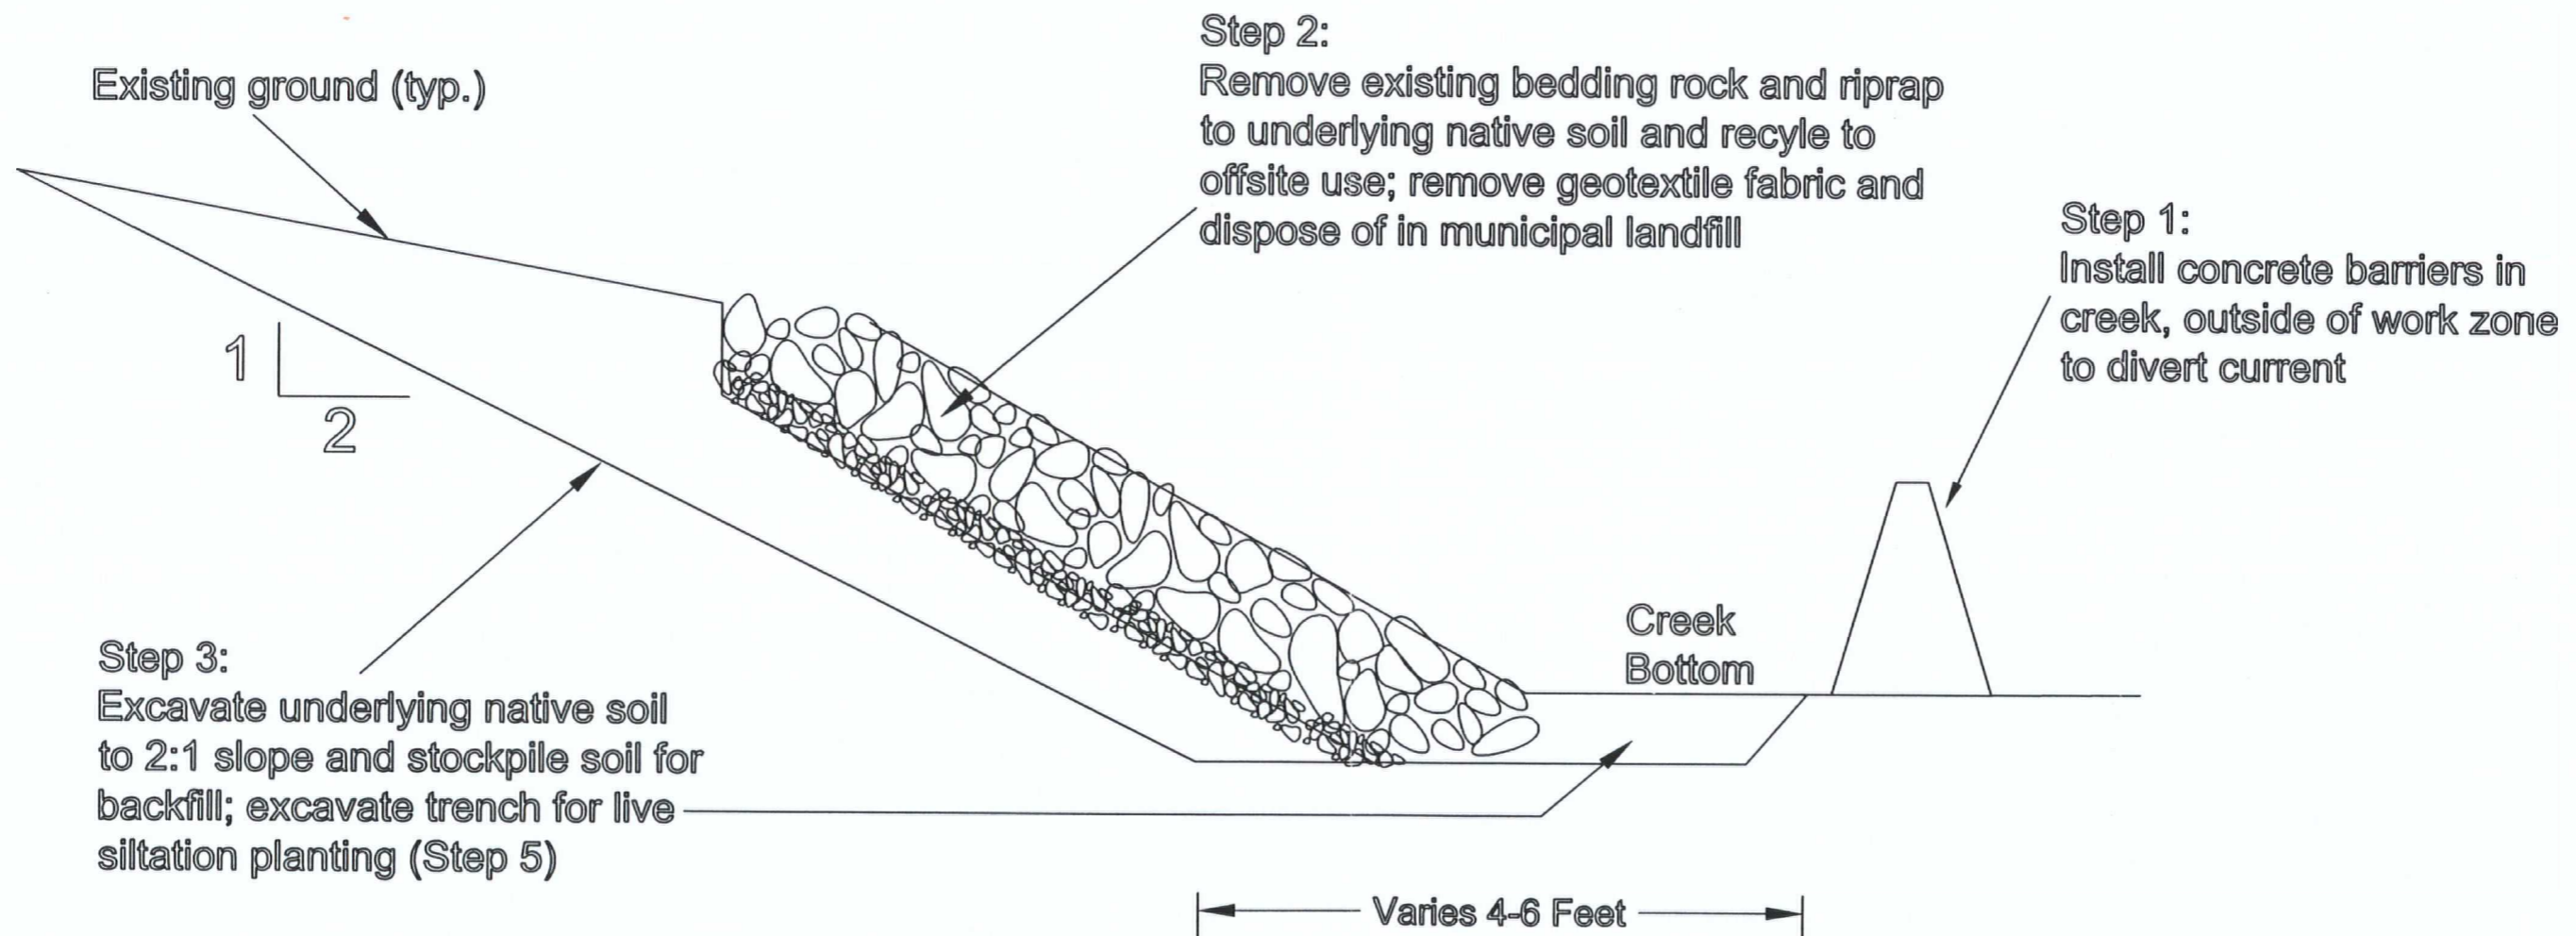
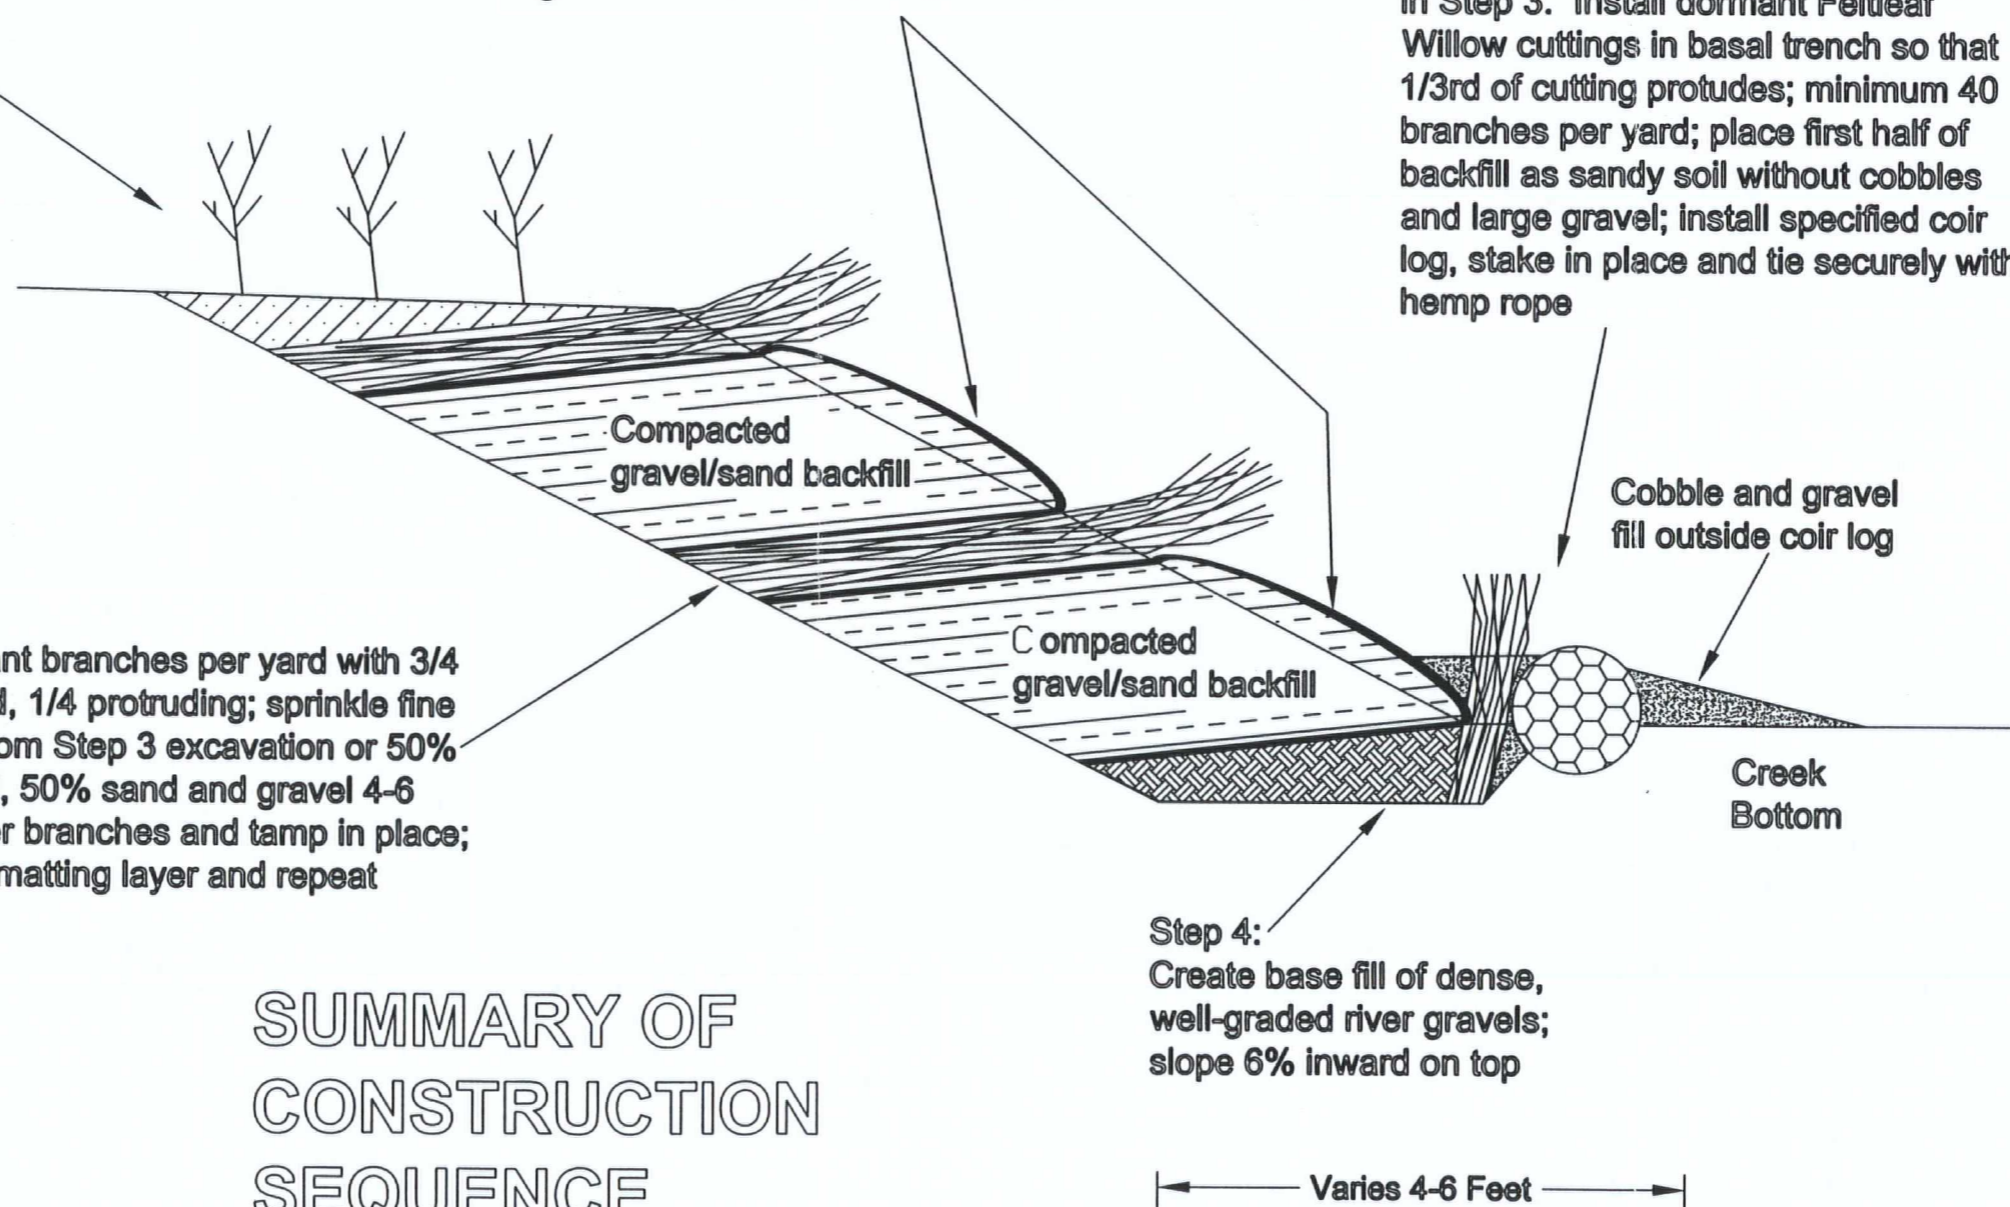
FIGURE
9-3B

Step 7:
Install 25 dormant branches per yard with 3/4 of branch buried, 1/4 protruding; sprinkle fine silty sand soil from Step 3 excavation or 50% imported topsoil, 50% sand and gravel 4-6 inches thick over branches and tamp in place; install next coir matting layer and repeat sequence

SUMMARY OF CONSTRUCTION SEQUENCE

Step 4:
Create base fill of dense, well-graded river gravels; slope 6% inward on top

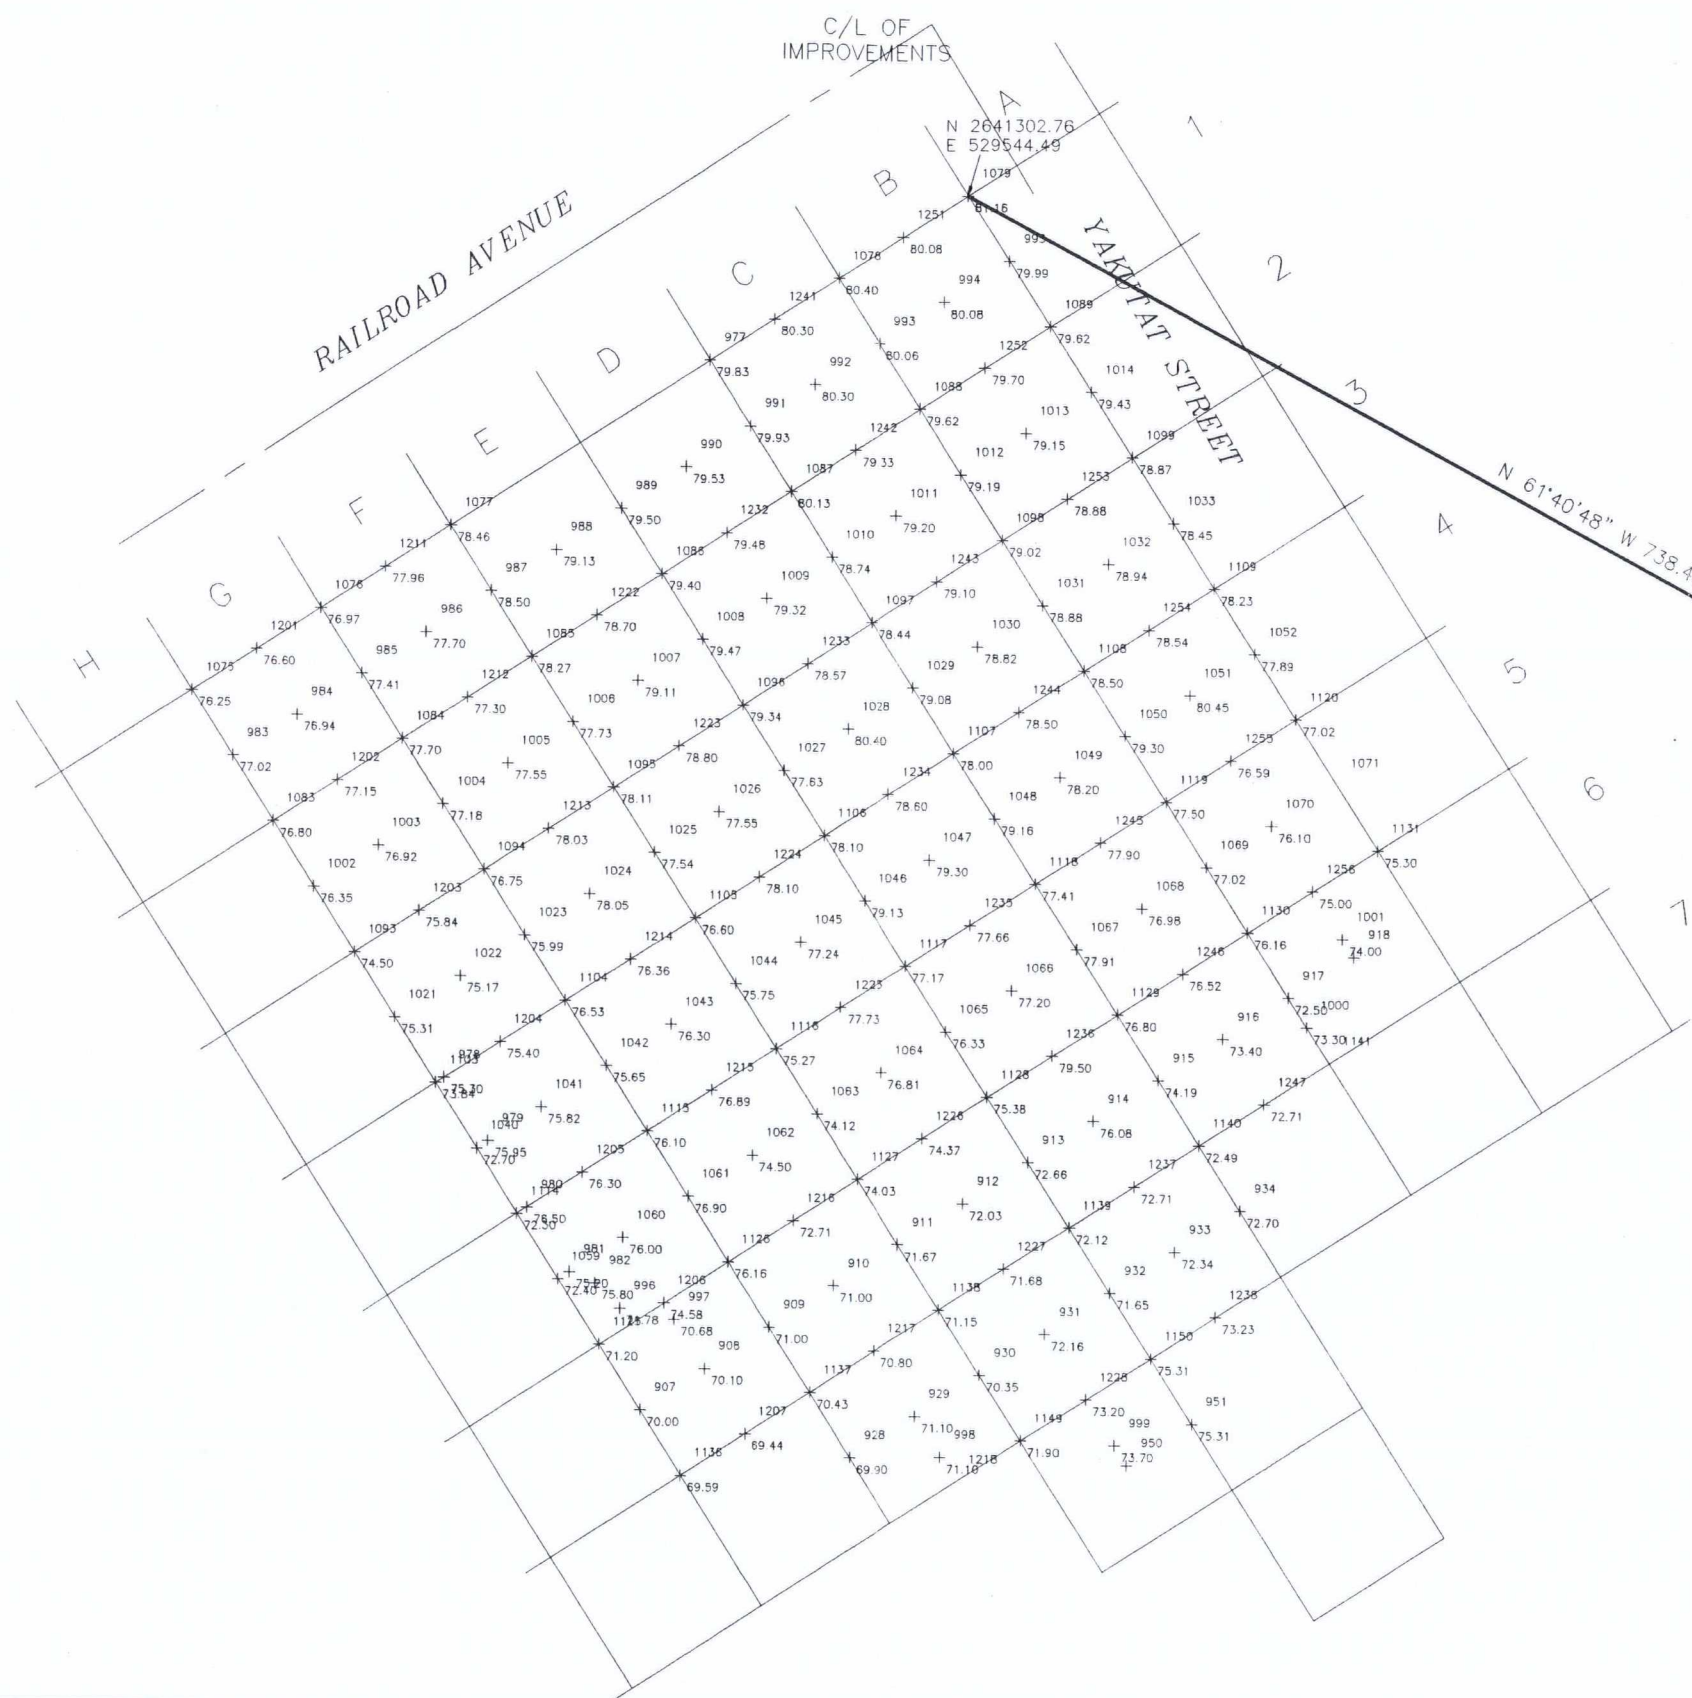
SHEET
1
OF
10

ORIGINAL GROUND

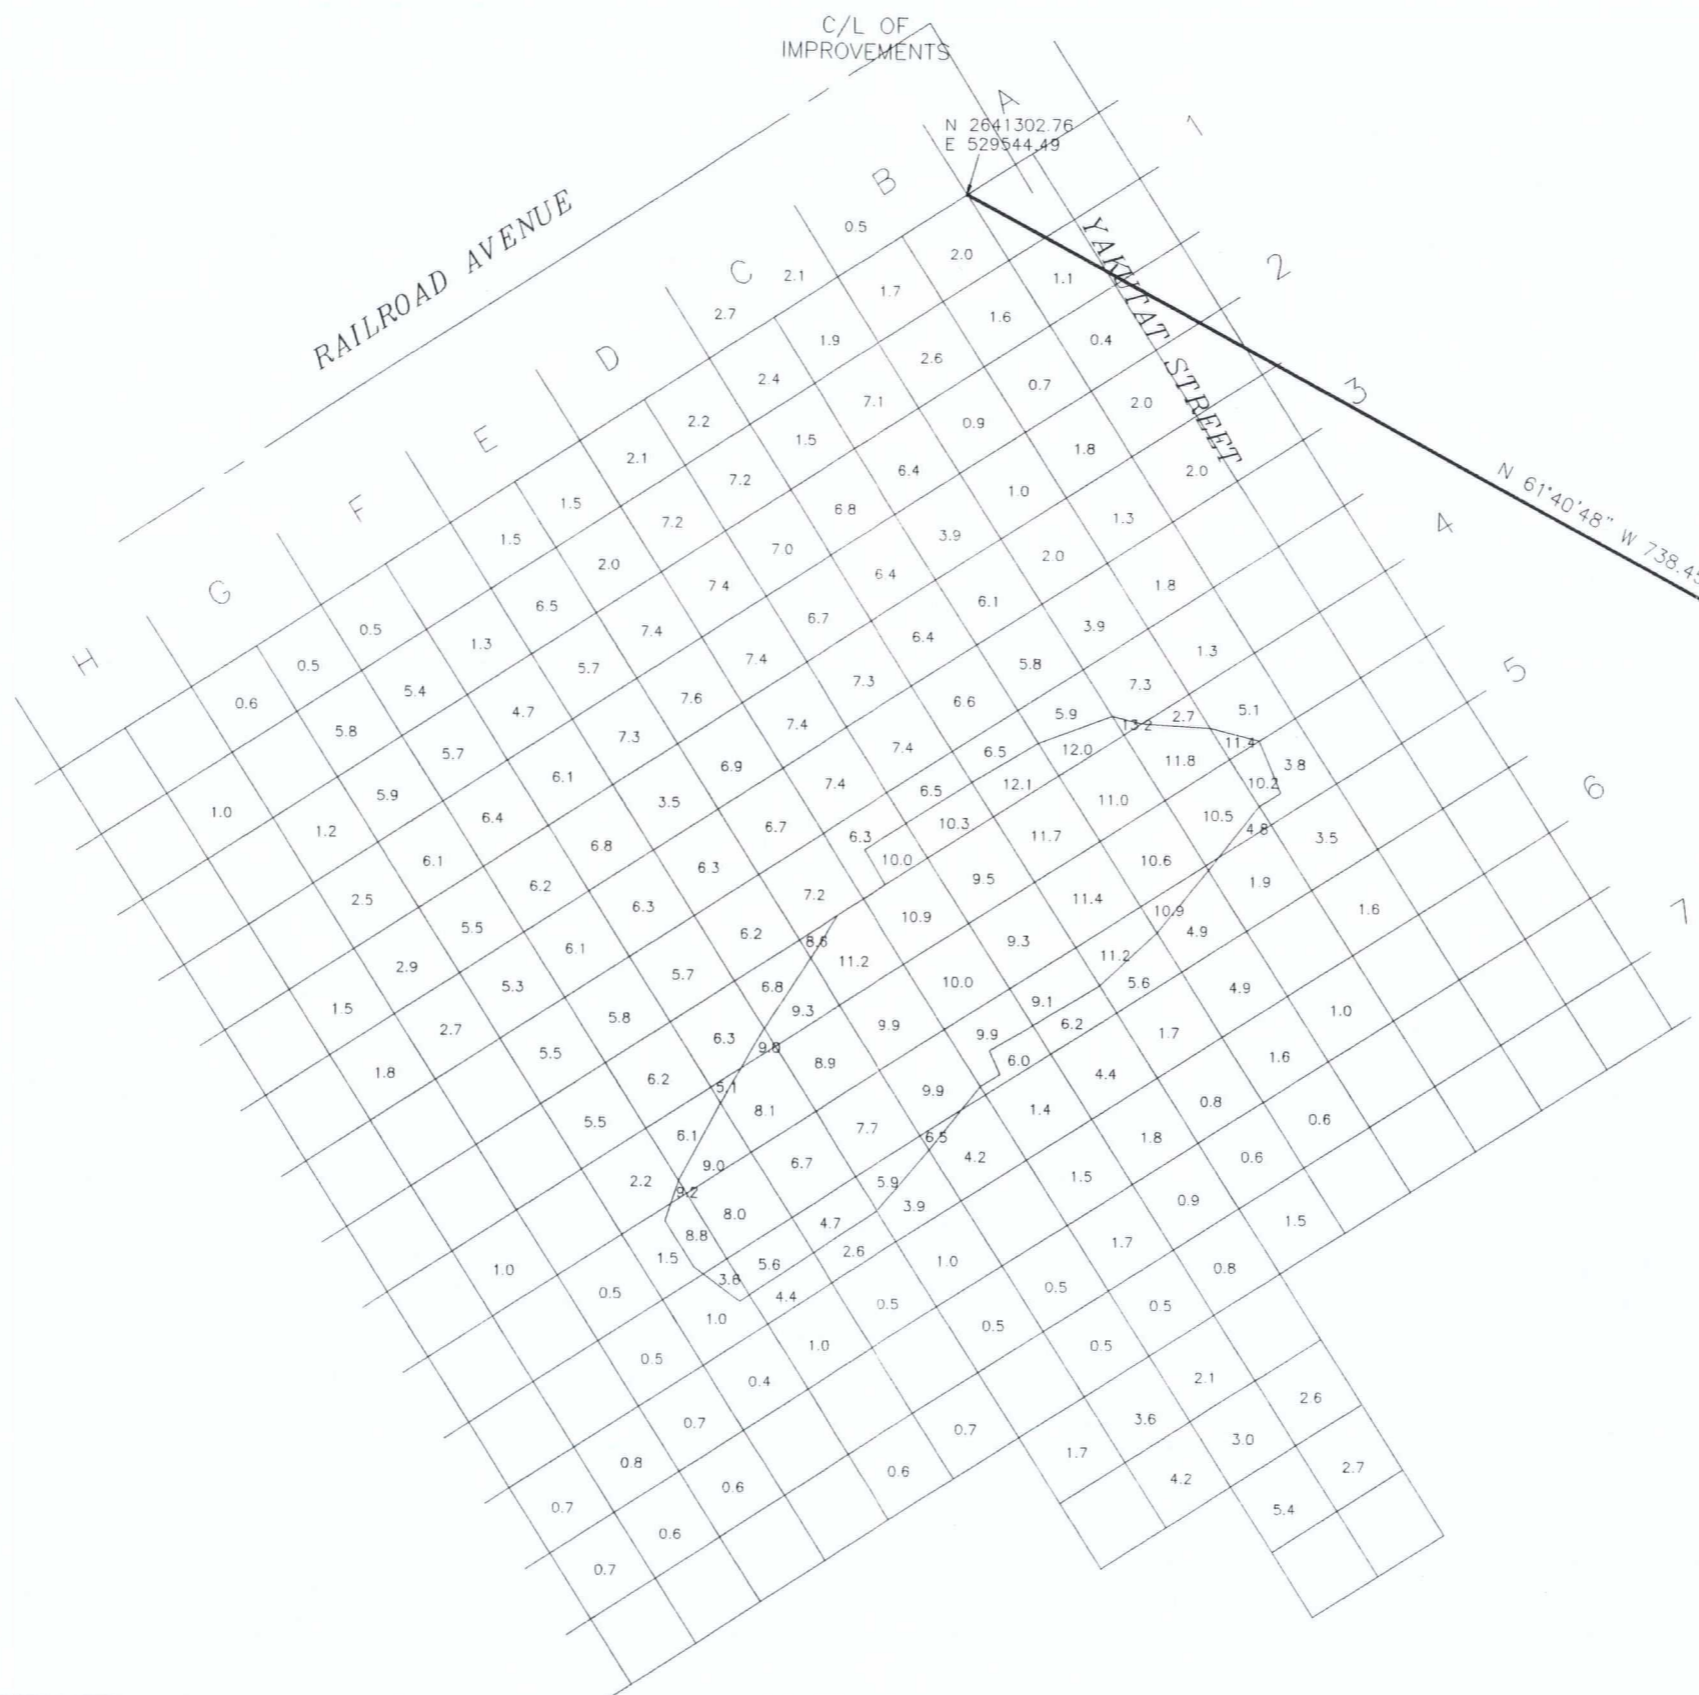
SHEET
3
OF
10

DEPTH OF EXCAVATION

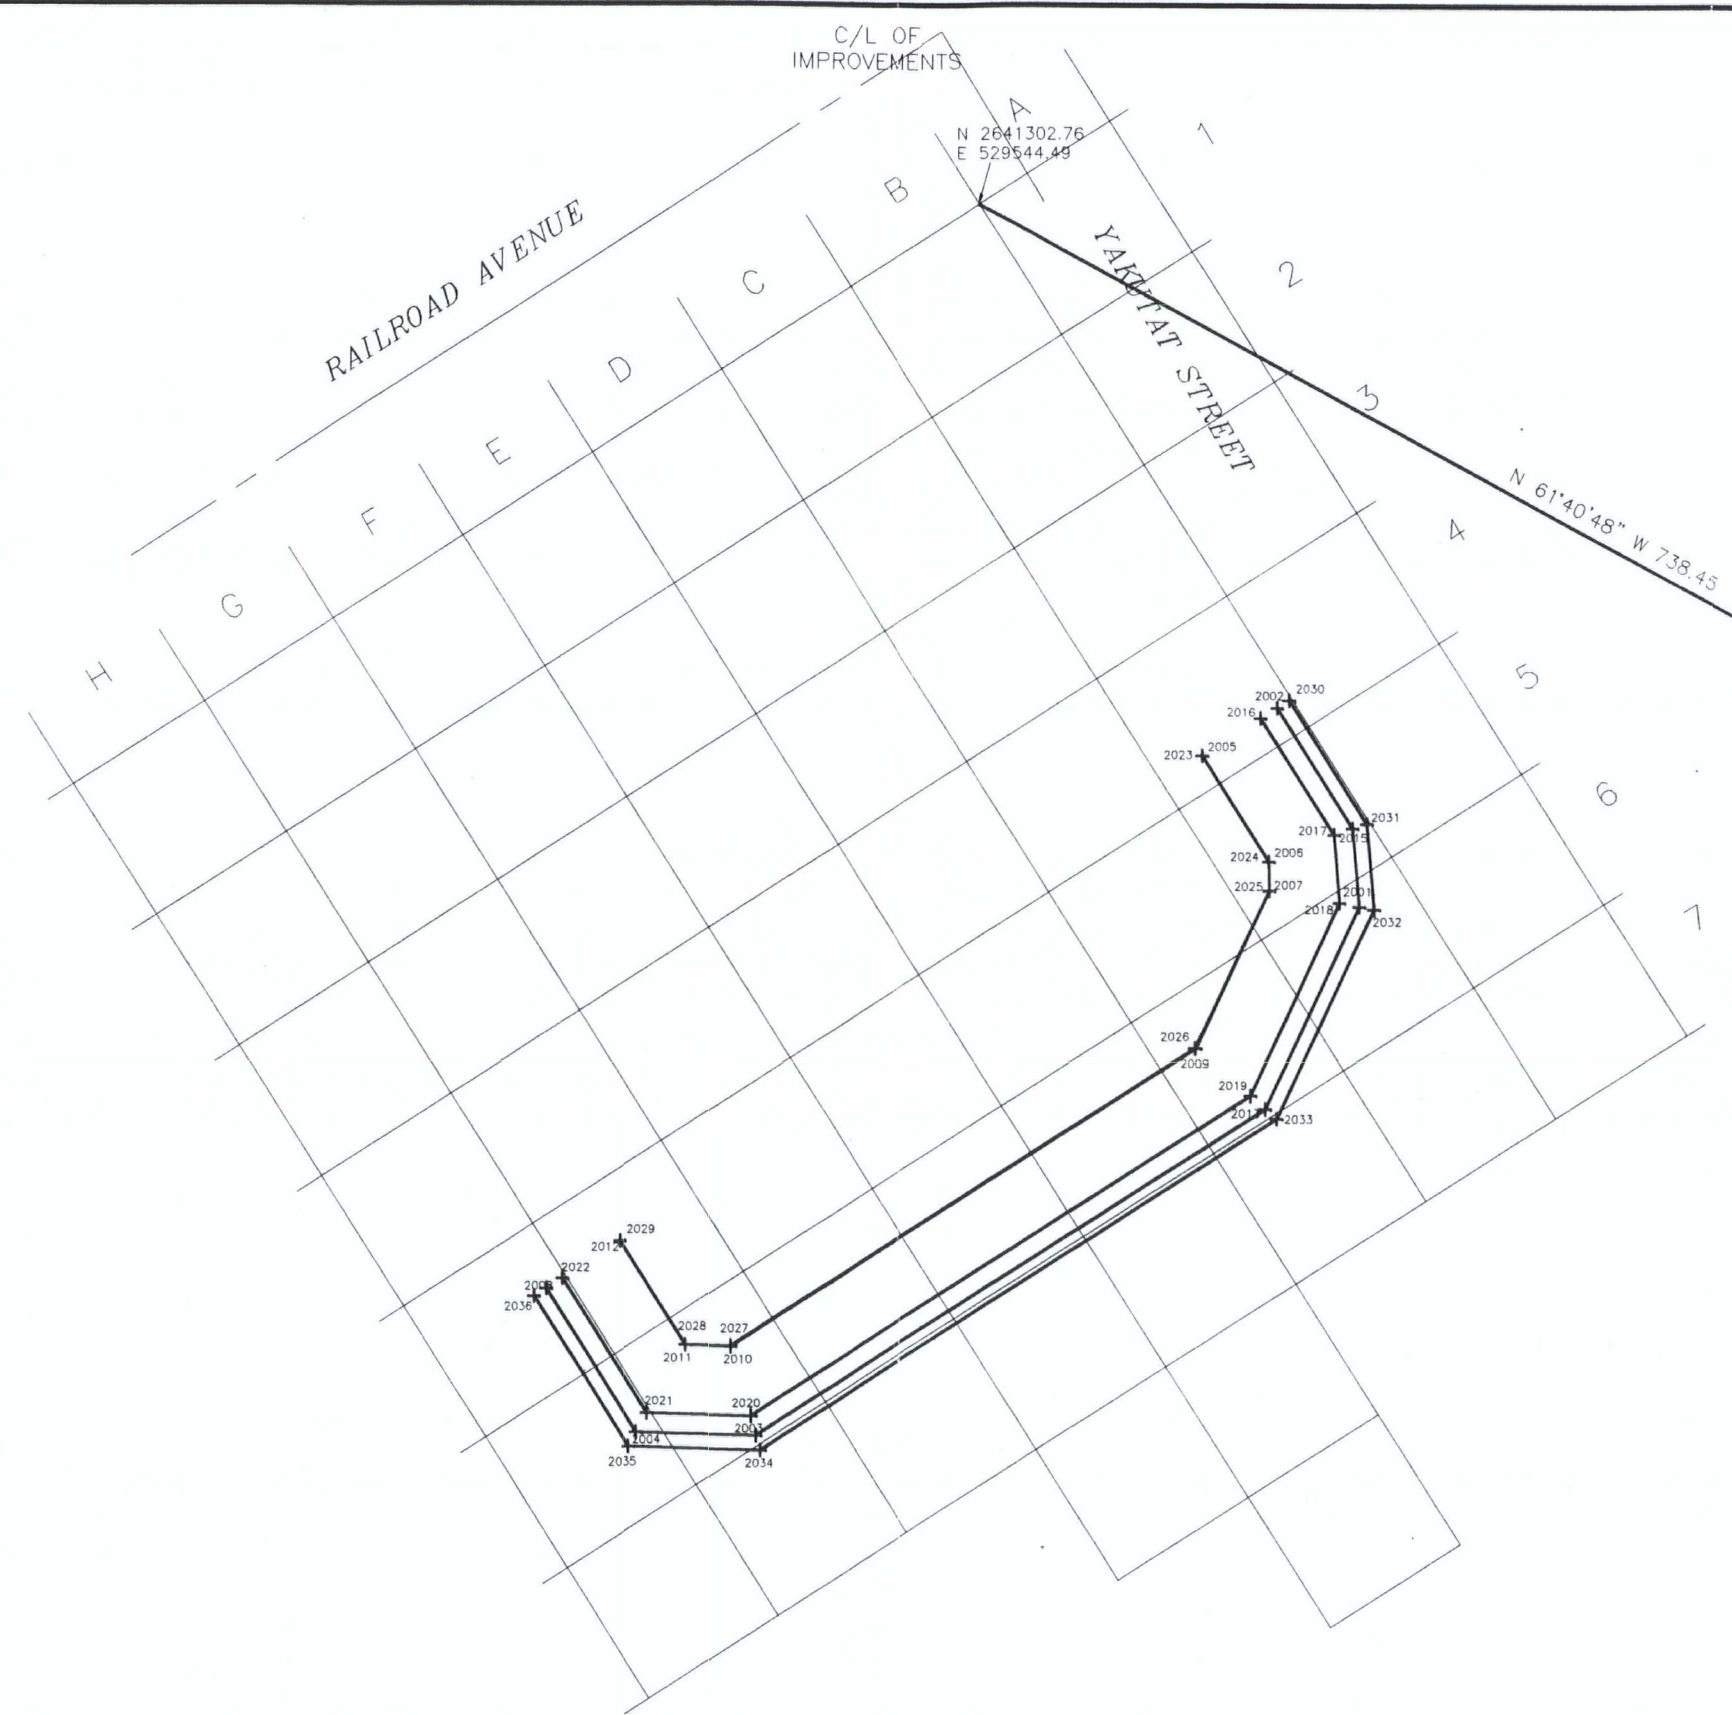
TOP INSIDE LIMITS OF RIP RAP			
PNT	NORTH	EAST	ELEV
2023	2641017.81	529661.28	83.00
2024	2640963.06	529696.28	83.00
2025	2640947.85	529696.55	83.00
2026	2640866.52	529658.40	83.00
2027	2640711.78	529416.28	83.00
2028	2640712.34	529392.52	83.00
2029	2640765.89	529358.26	83.00
BOTTOM EXCAVATION INSIDE LIMITS OF RIP RAP			
PNT	NORTH	EAST	ELEV
2005	2641017.86	529661.37	77.90
2006	2640963.09	529696.38	77.90
2007	2640947.83	529696.65	77.90
2009	2640866.45	529658.48	77.90
2010	2640711.68	529416.31	77.90
2011	2640712.24	529392.46	77.90
2012	2640765.84	529358.18	77.90
INSIDE TOE RIP RAP EXCAVATION			
PNT	NORTH	EAST	ELEV
2016	2641037.26	529691.69	60.00
2017	2640976.93	529730.15	60.00
2018	2640941.52	529733.18	60.00
2019	2640842.08	529687.21	60.00
2020	2640675.63	529426.84	60.00
2021	2640676.90	529372.55	60.00
2022	2640746.56	529328.02	60.00

OUTSIDE TOE RIP RAP EXCAVATION			
PNT	NORTH	EAST	ELEV
2001	2640939.73	529743.37	60.00
2002	2641042.64	529700.13	60.00
2003	2640665.56	529429.66	60.00
2004	2640667.03	529367.00	60.00
2008	2640741.17	529319.59	60.00
2013	2640835.22	529695.06	60.00
2015	2640980.23	529739.91	60.00
OUTSIDE RIP RAP LIMITS			
PNT	NORTH	EAST	ELEV
2030	2641046.67	529706.45	65.00
2031	2640982.71	529747.22	65.00
2032	2640938.39	529751.01	65.00
2033	2640830.09	529700.95	65.00
2034	2640658.01	529431.77	65.00
2035	2640659.62	529362.83	65.00
2036	2640737.13	529313.27	65.00

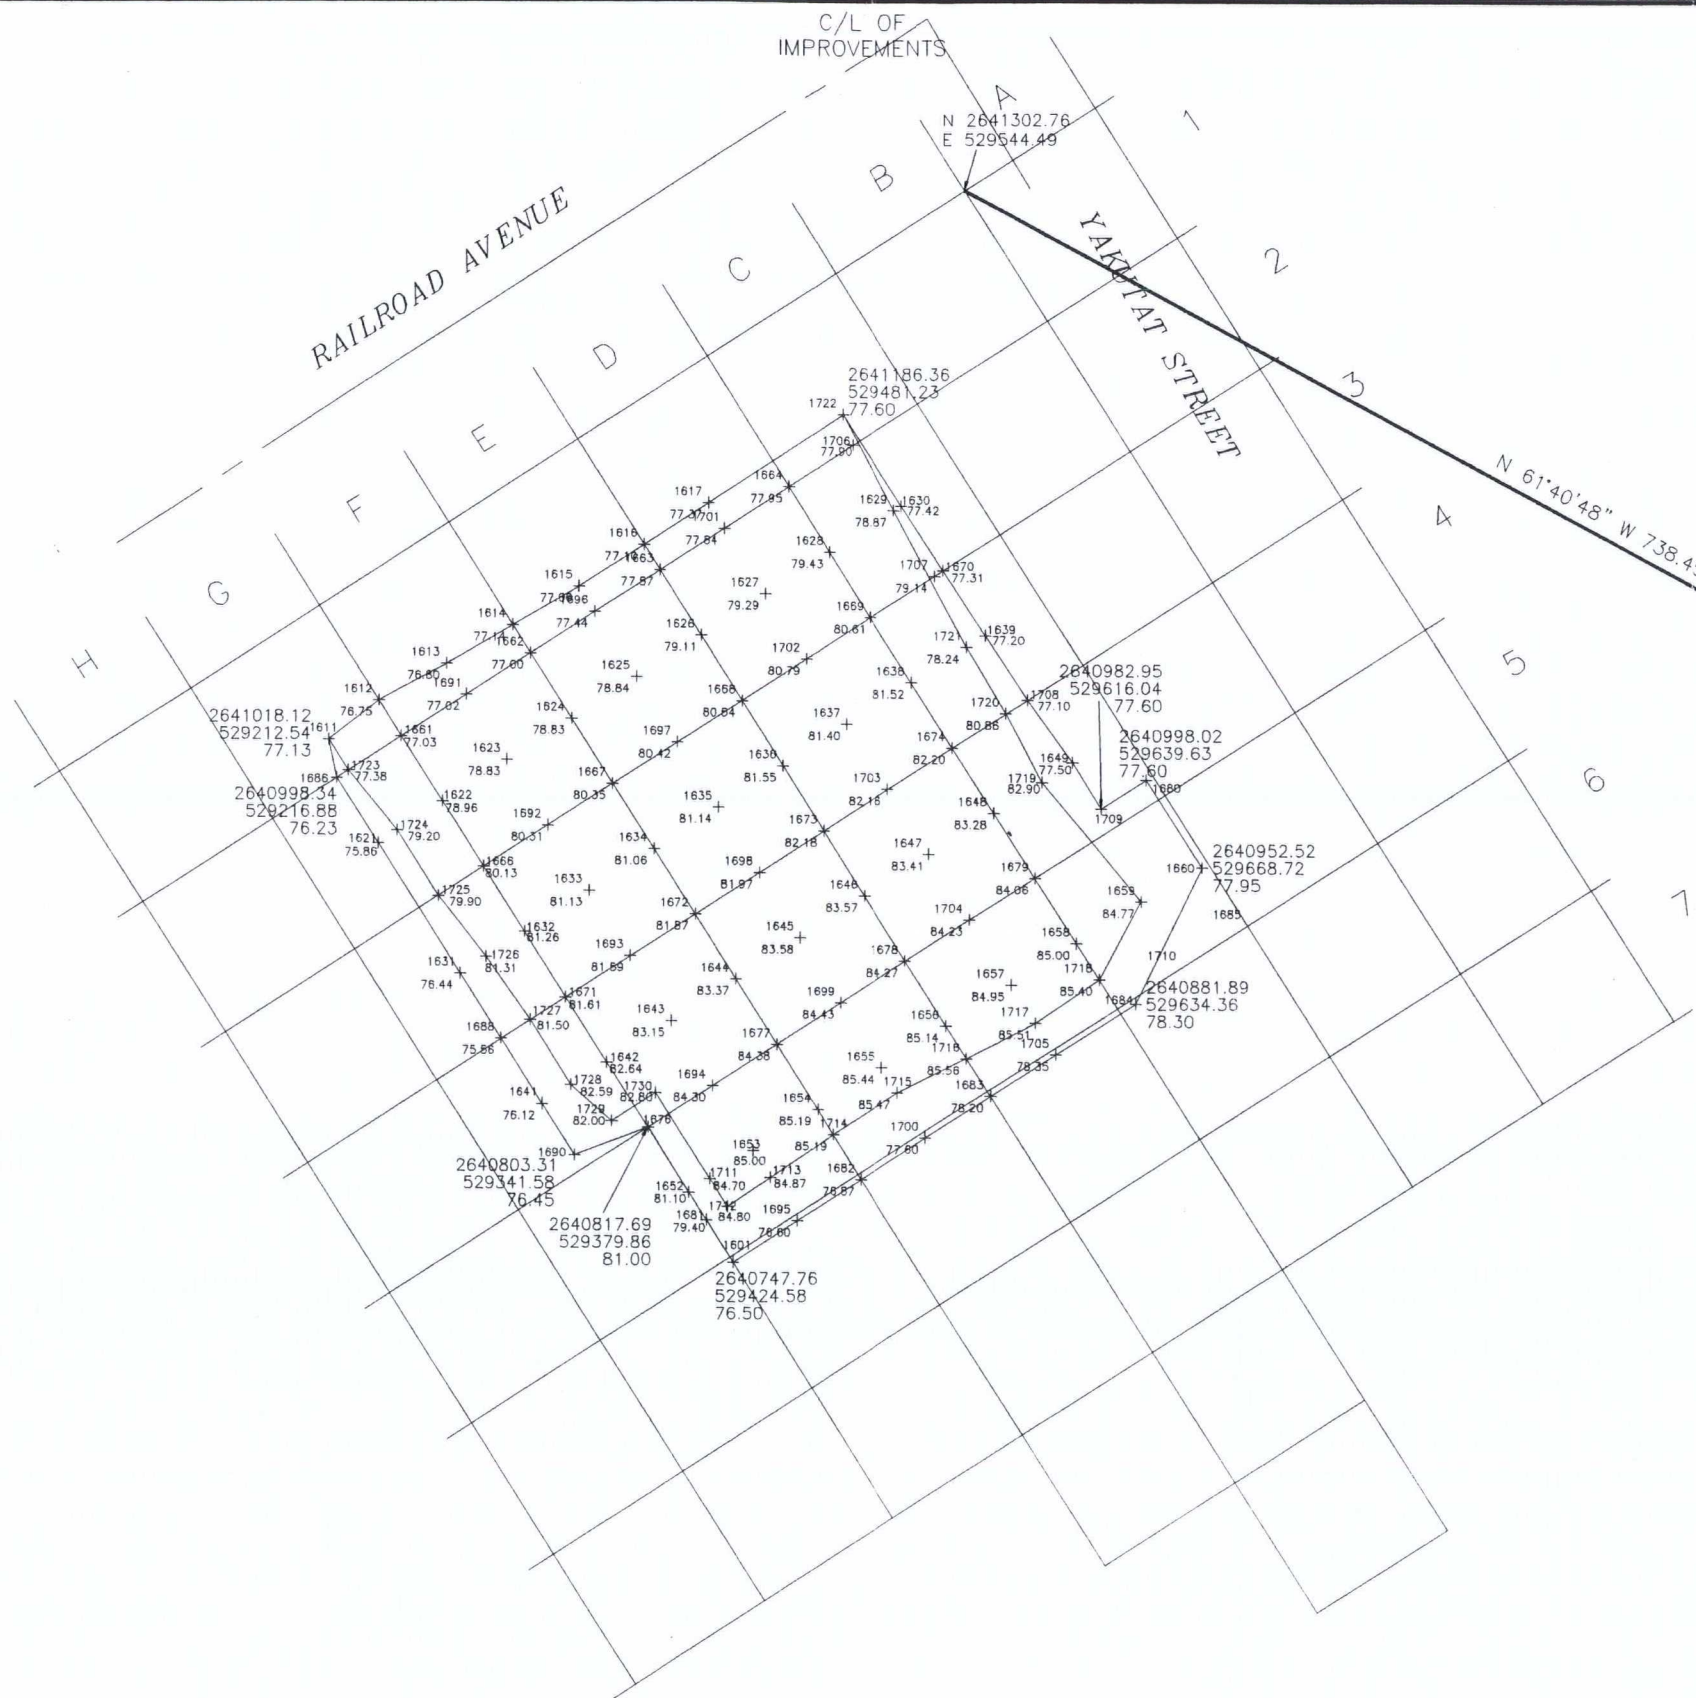
SHEET
7
OF
10

ANCHOR TRENCH
AND
ANCHOR TRENCH PIPE

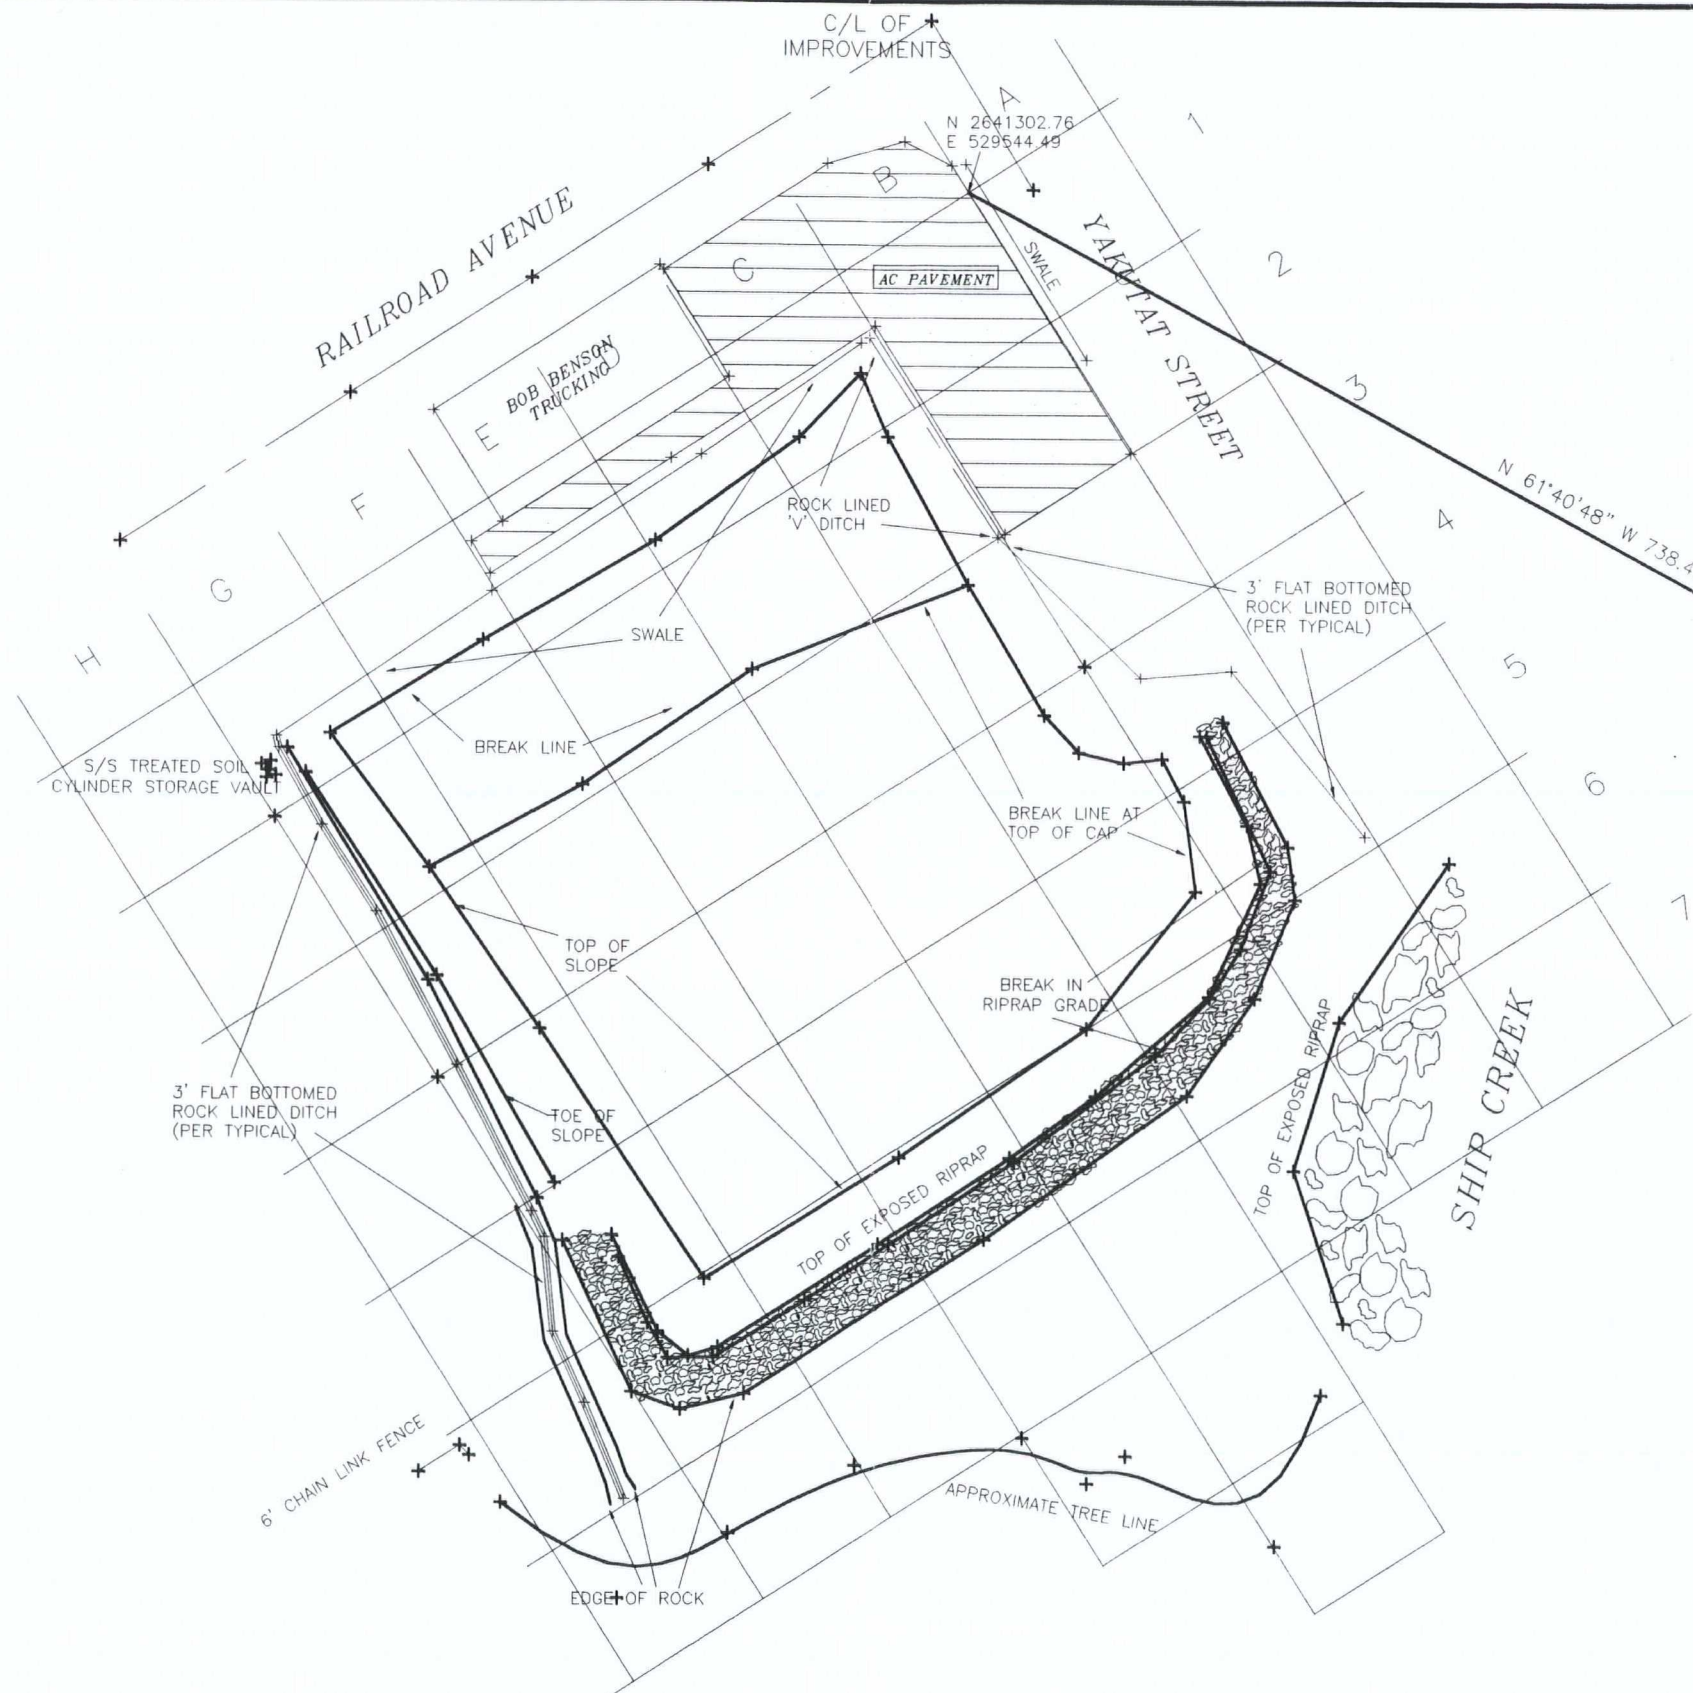
SHEET
8
OF
10

TOP SOLIDIFIED SOIL/
GEO-MEMBRANE

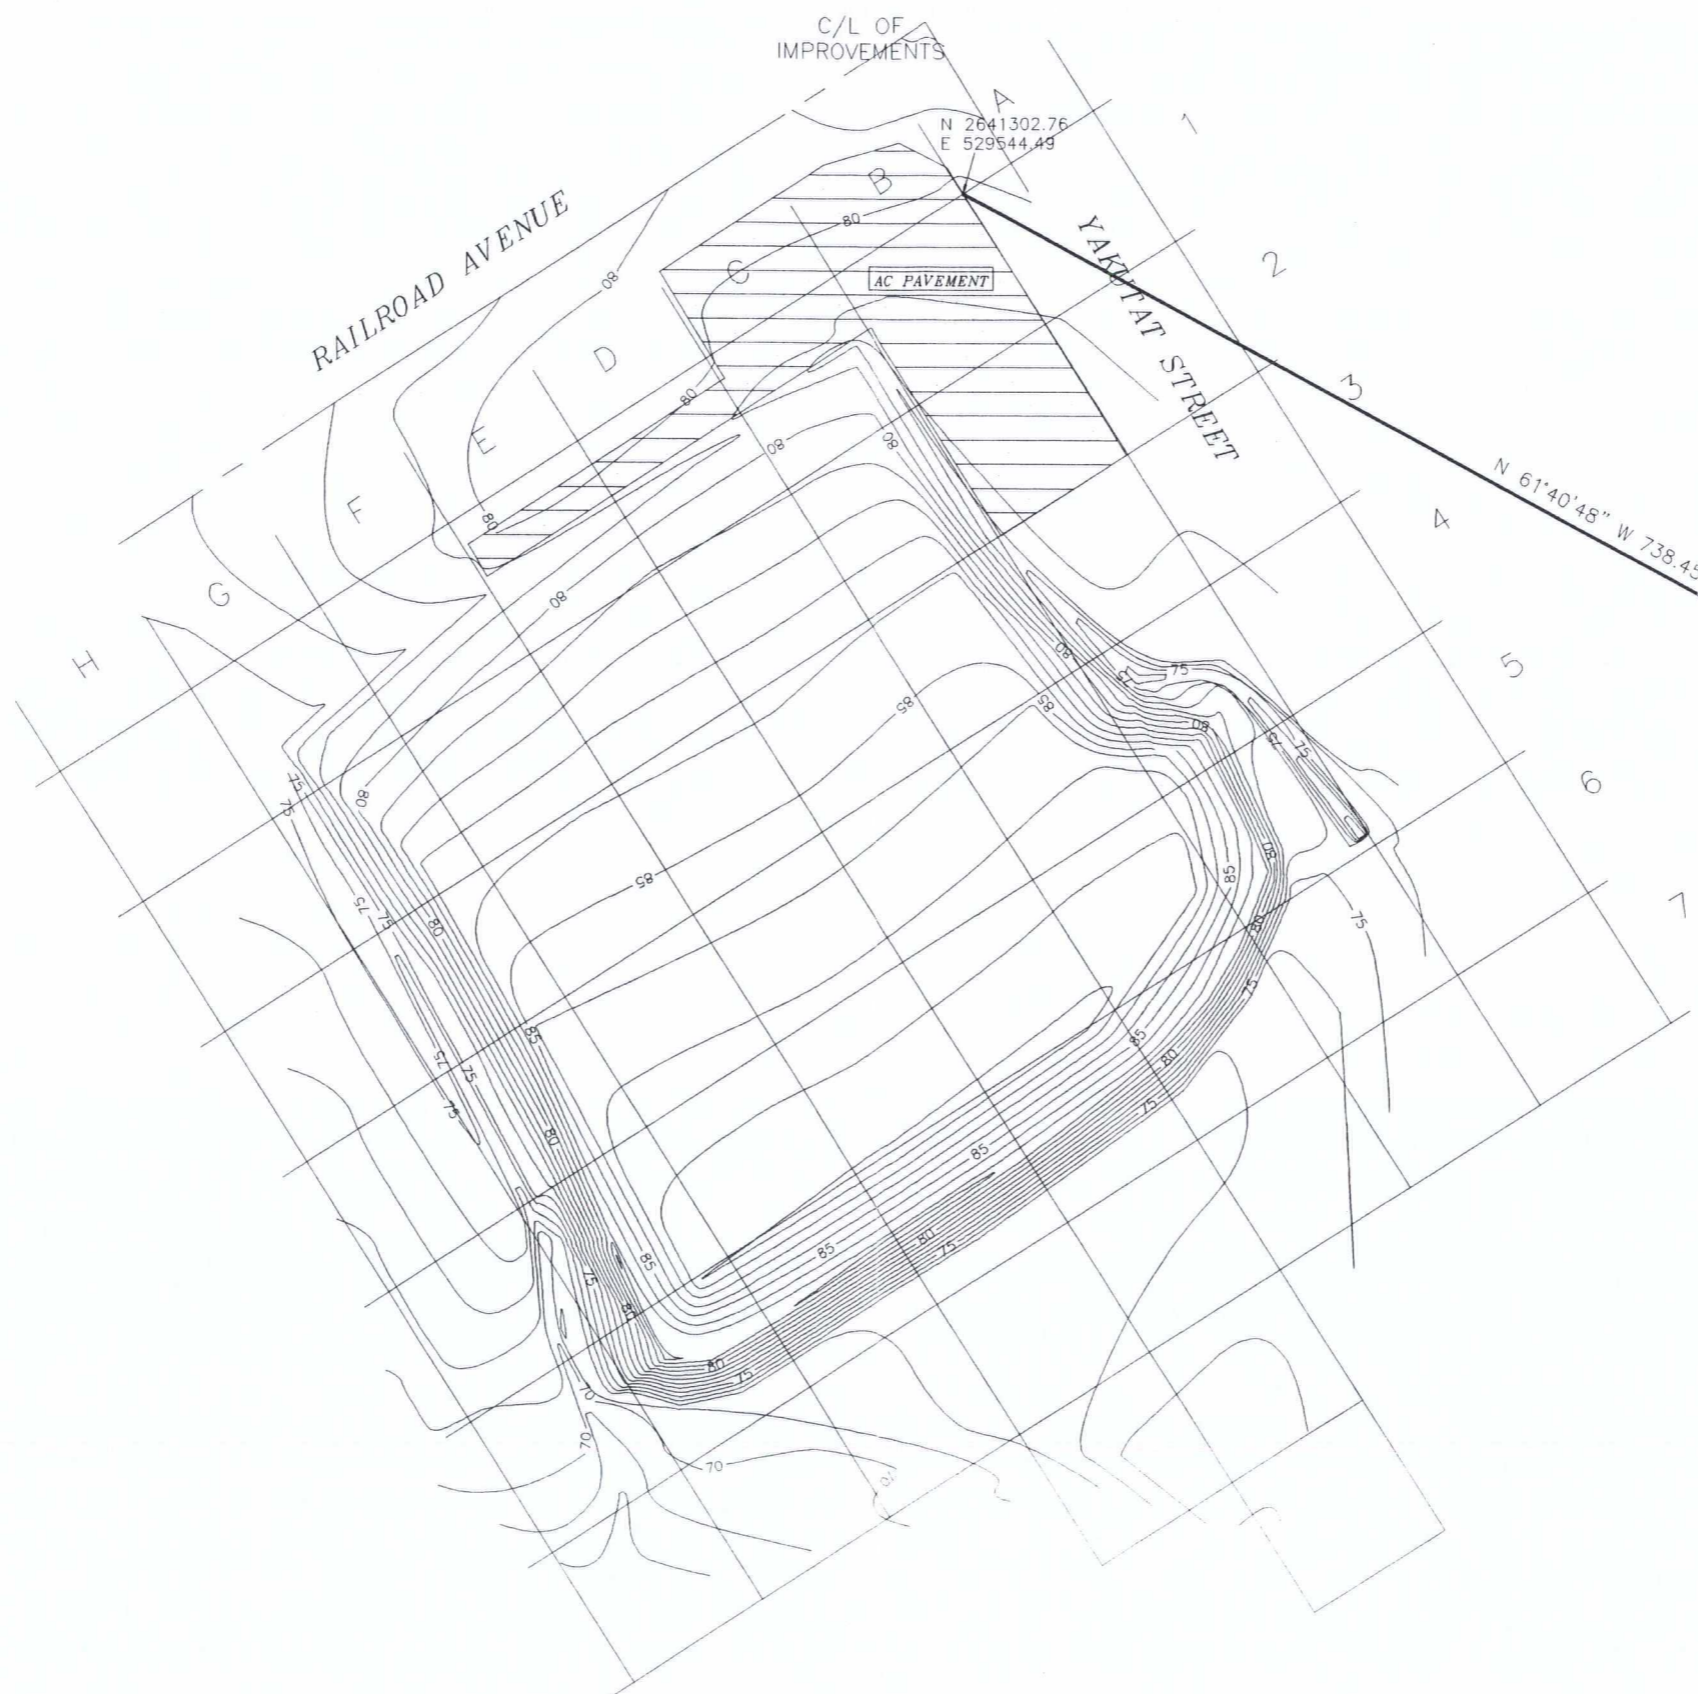
SHEET
9
OF
10

POST CONSTRUCTION
ASBUILT
